## Home Inspection Report

3100 Anywhere Ct., Aurora, CO 80013

Tuesday, September 24, 2019

Seamless Home Inspection, LLC

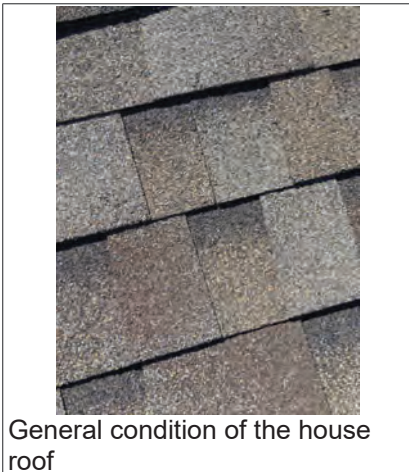
**Comments** There are several spongy areas on the roof.

General condition of the house roof

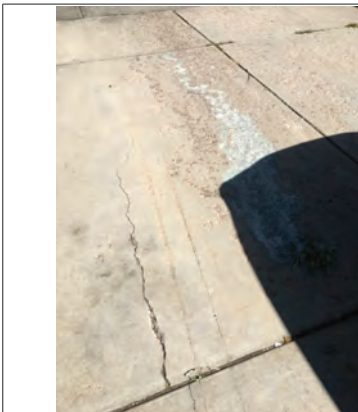
The driveway and front steps have areas of spalling. Spalling can not be successfully patched. Monitor and replace the slab/steps as needed.

The driveway has normal cracking. Recommend sealing the cracks with a product like Sikaflex to help prevent additional damage.

Driveway. Note: spalling and typical cracks

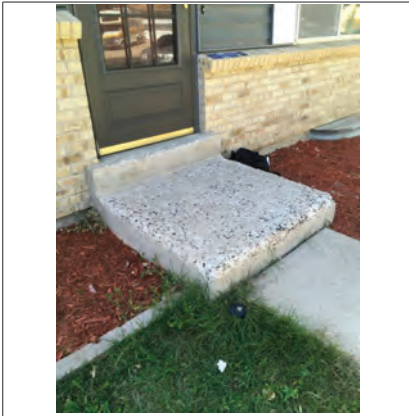
☐ None  
**Material** ☒ Concrete ☐ Wood Other: ☐ Railing/Balusters recommended  
**Condition** ☐ Satisfactory ☒ Marginal ☐ Poor ☐ Safety Hazard ☐ Uneven risers ☐ Rotted/Damaged  
☐ Cracked ☐ Settled ☐ Typical Cracks  
**Comments** The stoop/steps have areas of spalling. Spalling can not be successfully patched. Monitor and replace the slab as needed.

Front steps

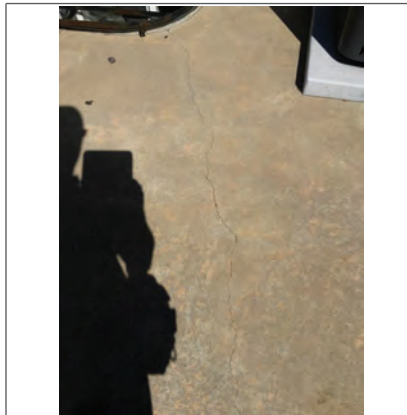
Typical concrete cracks

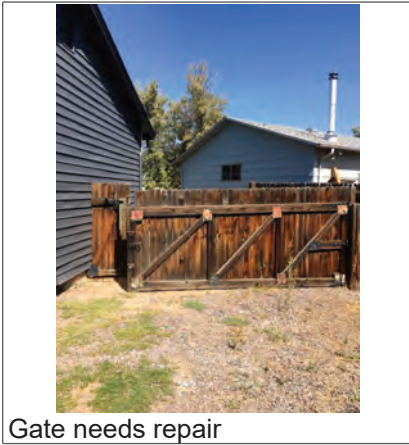
- ☐ Not evaluated ☐ None  
☐ Brick ☐ Block ☐ Wood ☐ Metal ☒ Chain Link ☐ Rusty ☐ Vinyl  
☒ Satisfactory ☐ Marginal ☐ Poor ☐ Typical cracks ☐ Loose Blocks/Caps  
☐ N/A ☐ Satisfactory ☐ Marginal ☒ Poor ☐ Planks missing/damaged Operable: ☐ Yes ☒ No  
 Gate is difficult to open and close. Repair as needed.

Gate needs repair

Fence gate is difficult to open and close. Repair as needed.

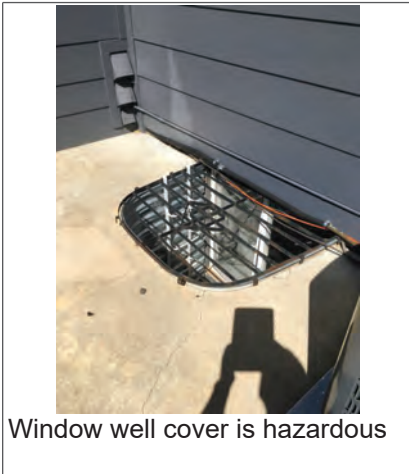
**Comments** The existing window well covers are a hazard as the spacing is wide enough to step through.  
 The front window well covers are wooden and deteriorating. Recommend replacing with safer designs.

Window well cover is hazardous

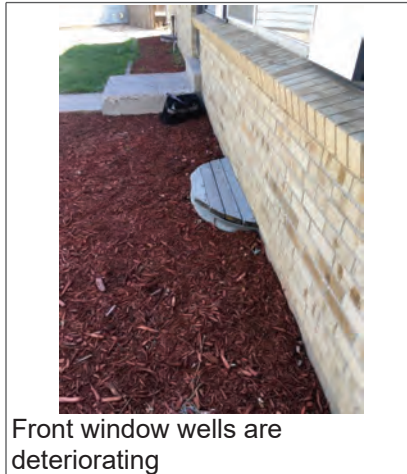
Front window wells are deteriorating

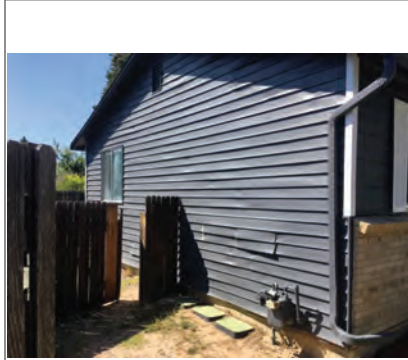
Damaged siding on side of home

House siding on east end had damage, recommend a licensed contractor repair/replace damaged sections.

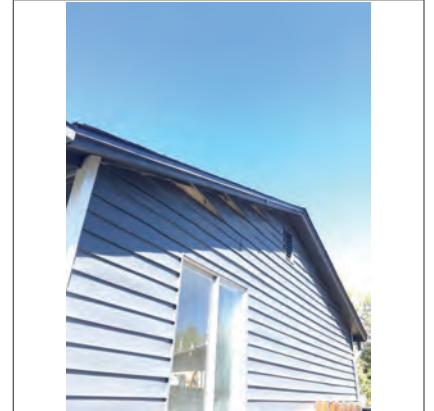
Damaged siding on home

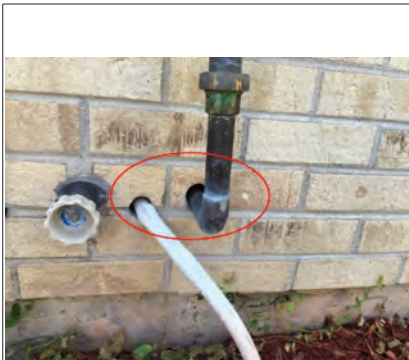
Recommend caulking around wall penetrations

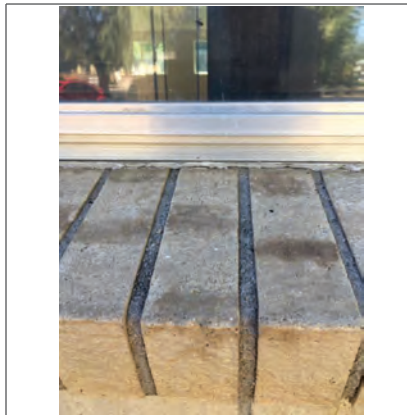
Caulking is dried around windows. Replace

Caulking dried and cracked, recommend removing and replacing.

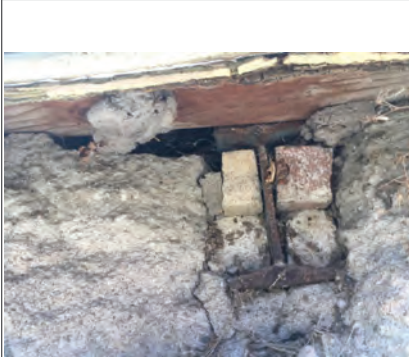
**Comments** Beam push out observed on foundation wall. See photo. Recommend repair.

Foundation is damaged on side of home. Repair recommended

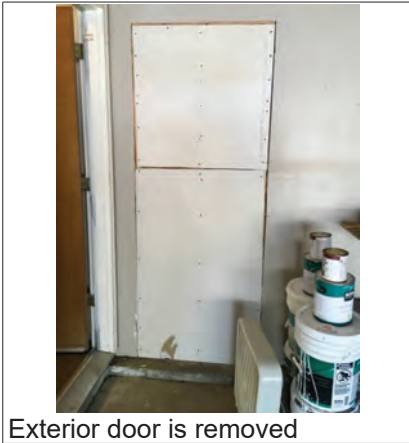
**Condition** ☒ None ☐ Satisfactory ☐ Marginal ☐ Poor ☐ Damaged/Rusted  
**Comments** Exterior door was removed and covered over.

Exterior door is removed

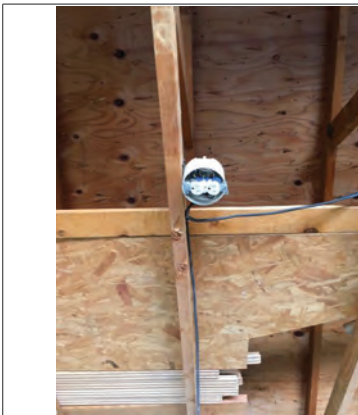
Incorrect electrical box for receptacle. Missing cover plate

There is at least one cover plate missing at a receptacle in the garage. This is a safety concern. Recommend a licensed electrician install a cover plate.

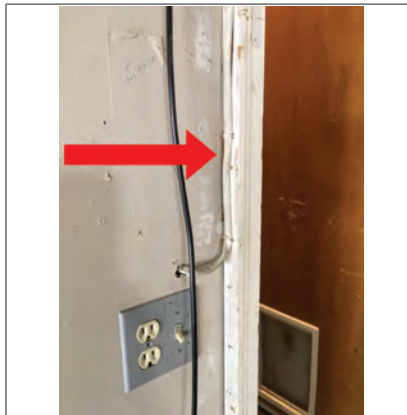
Electrical wiring not in conduit

Wiring in the garage is not correctly enclosed in conduit. This is a safety concern. Recommend a licensed electrician repair.

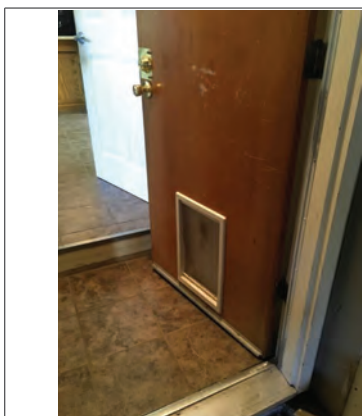
**Comments** The door leading into home from the garage is not fire-rated, recommend a fire rated door for improved safety. This is a safety hazard.

Door leading to home is not a fire door

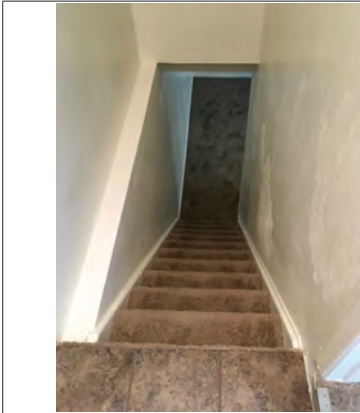
Basement stairs. Note: missing handrail

Handrail missing on basement stairs, potential safety issue. Recommend installing a handrail.

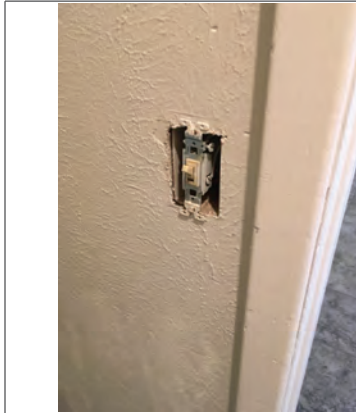
Missing switch cover plate

Missing switch cover plate. Safety hazard. Install cover plate as required.

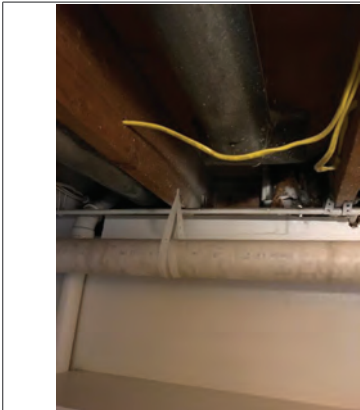
Insulation is missing on rim joists

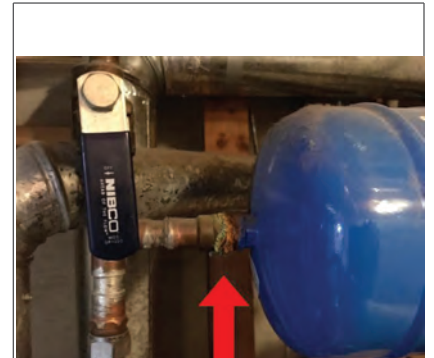
There are corroded pipes at the water heater. Recommend a licensed plumber repair.

Corrosion at expansion tank

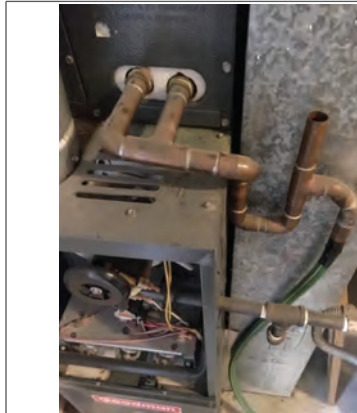
House air conditioning primary and secondary condensate lines are piped together. This does not allow for the secondary line to be effective if the line gets blocked. Repair as needed.

Primary and the secondary lines are piped together

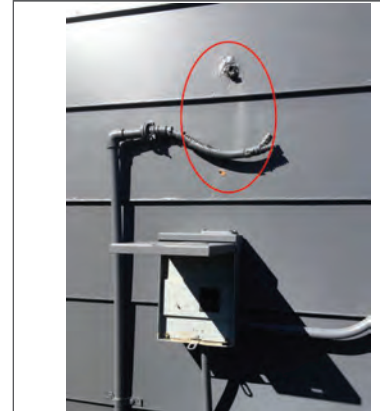
Outbuilding condensate line is not connected at wall and may discharge on top of sub panel enclosure in current condition. Recommend repair. See photo.

Condensate line is disconnected

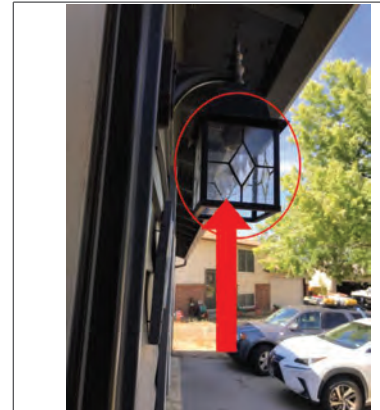
Exterior front light that not illuminate. Recommend replacing the bulb and retesting.

Replace light and retest

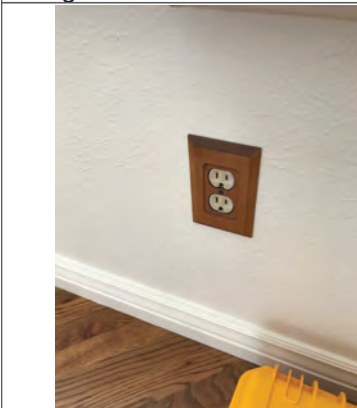
Damaged receptacle

There are several damaged receptacles. Recommend licensed electrician replace.

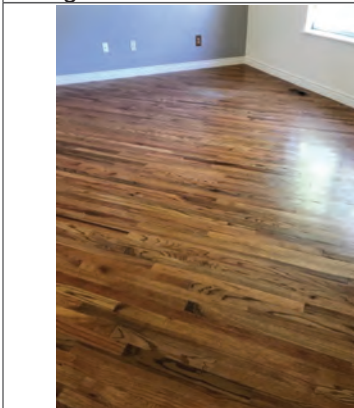
Wood floor has areas of floor finish that is worn

Wood floor finish is showing signs of wear. Refinish to protect wood.

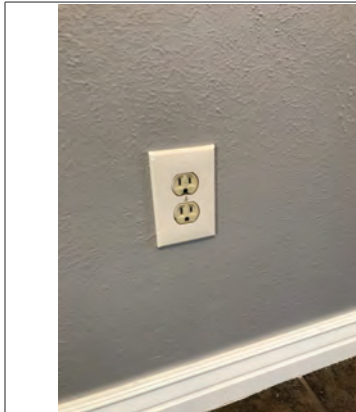
Damaged receptacle

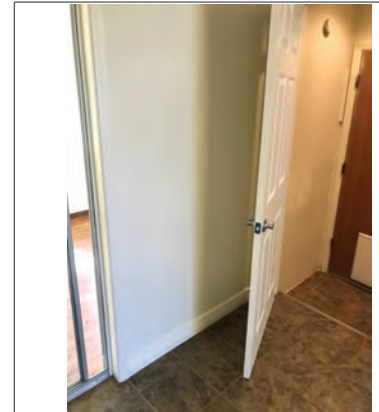
No door stop

[Recommend installing a door stop. Door stops help prevent damage to the wall from the door knob.](#)

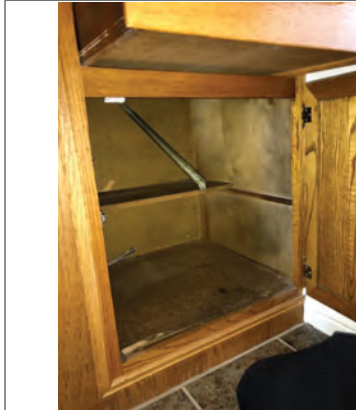
**Comments** There are damaged cabinets in the kitchen. Repair or replace as needed.

Drawer guide neds repair

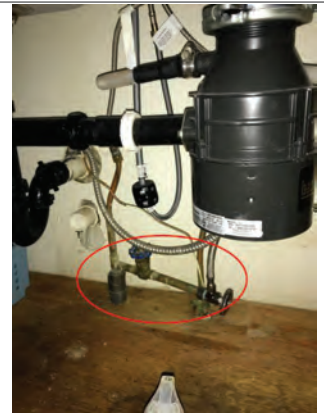
Some minor corrosion around the plumbing joints, but no visible leaks at this time. Monitor for leaks.

Corrosion present. Monitor for leaks.

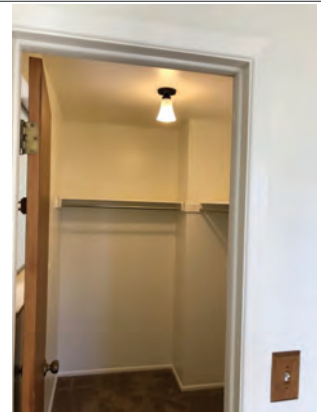
Recommend enclosed LED light fixture in closet

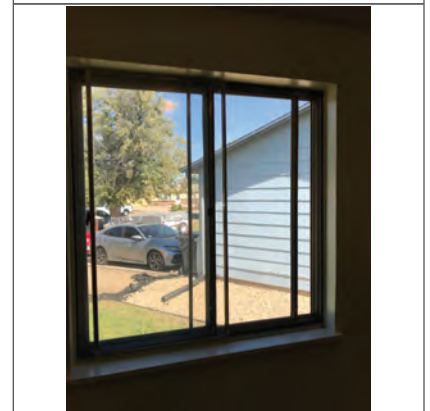
Missing screen

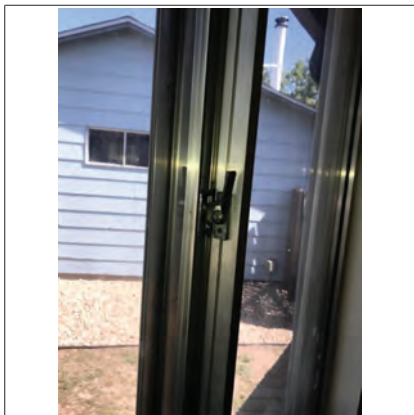
The latch of one window is difficult to use. Recommend repair or replace.

Latch is difficult to lock

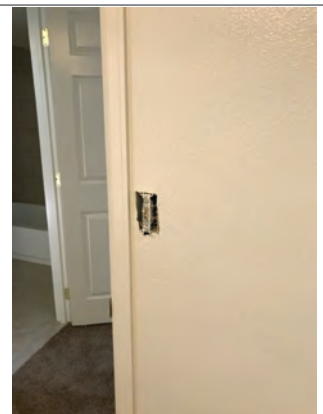
Cover plate missing

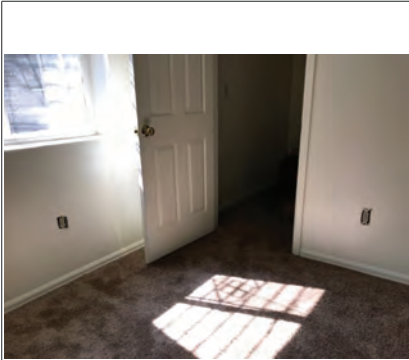
Missing receptacle plate

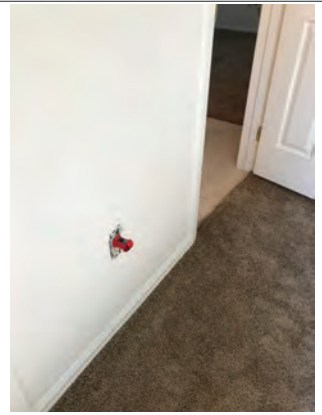
Loose receptacle and missing cover plate

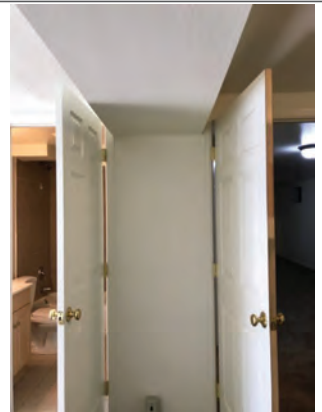
Missing door stops

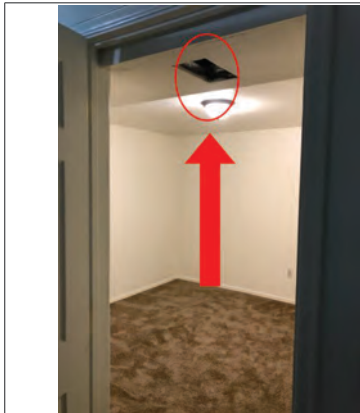
**Comments** [Missing heater grill cover. Replace.](#)  
[Recommend replacing incandescent light with a enclosed LED light.](#)

Missing vent cover

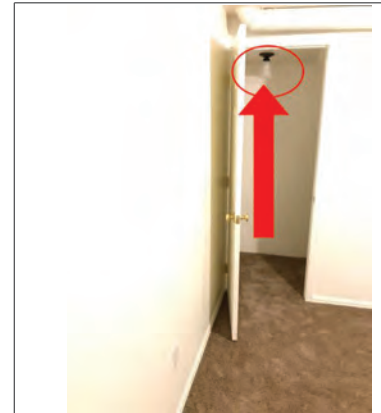
Recommend replacing incandescent light with a enclosed LED light

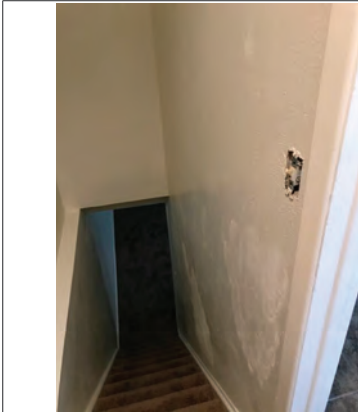
☐ None  
**Condition** ☐ Satisfactory ☐ Marginal ☐ Poor ☒ Loose/Missing  
**Handrail** ☐ Satisfactory ☐ Marginal ☐ Poor ☒ Safety hazard ☒ Hand Rail/Railing/Balusters recommended  
**Risers/Treads** ☐ Satisfactory ☐ Marginal ☐ Poor ☒ Risers/Treads uneven ☐ Trip hazard  
**Comments** The switch at the bottom of the stairs is loose. Recommend replacing by licensed electrician.  
 There is a cover plate missing. This is a safety hazard. Have licensed electrician repair.  
 Handrail missing, potential safety issue. Recommend installing handrail.

Missing handrail  
Missing cover plate.

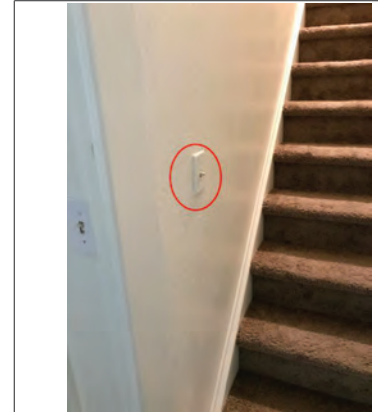
Loose switch
