## Home Inspection Report

3100 Anywhere Ct., Aurora, CO 80013

Tuesday, September 24, 2019

Seamless Home Inspection, LLC

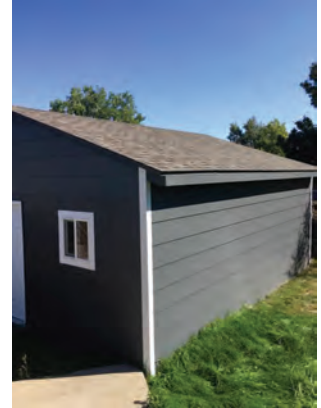
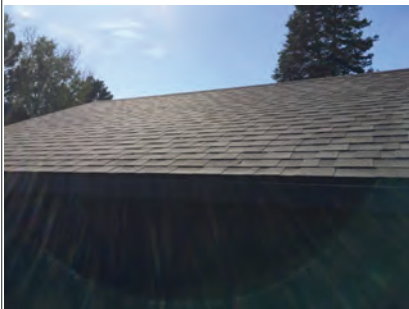
Outbuilding roof

The outbuilding did not have gutters or downspouts installed. Recommend installing

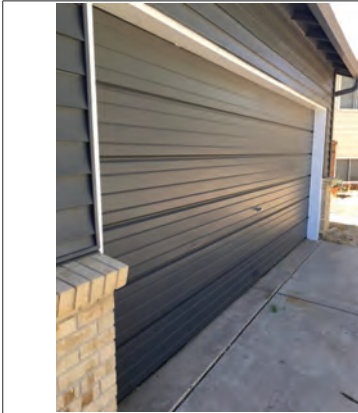
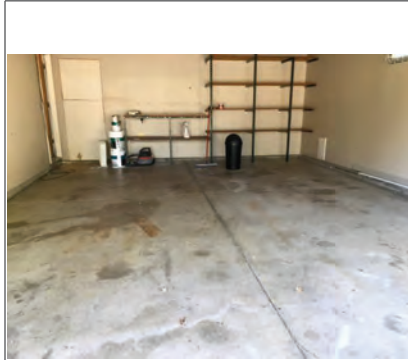
Garage

There are no GFCI's installed in the garage. This is a safety concern. Recommend a licensed electrician install GFCI receptacles.

There is at least one cover plate missing at a receptacle in the garage. This is a safety concern. Recommend a licensed electrician install a cover plate.

Wiring in the garage is not correctly enclosed in conduit. This is a safety concern. Recommend a licensed electrician repair.

There are loose receptacles in the garage. This is a safety concern. Repair as required.

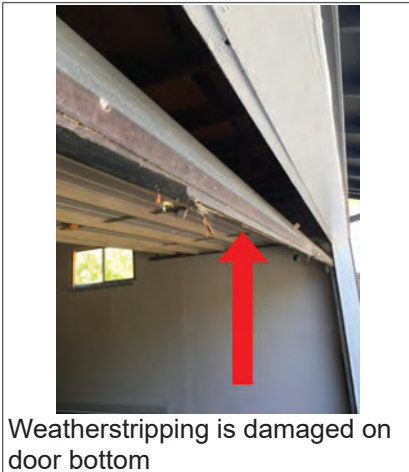
**Comments** Overhead garage door does not have a way currently to be locked.  
 Weatherstripping is damaged on bottom of door. Replace as needed.

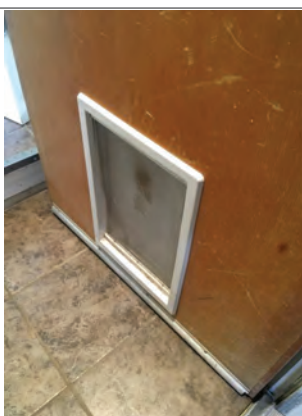
Pet door cut through door

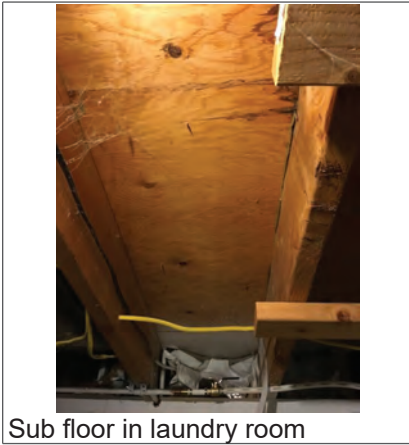
**Condition** ☐ Not Visible  
☐ Satisfactory ☐ Marginal ☐ Poor ☒ Indication of moisture stains/rotting  
**Comments** The Basement ceiling is finished. Subfloor is not visible. Inspection was limited.

Sub floor in laundry room

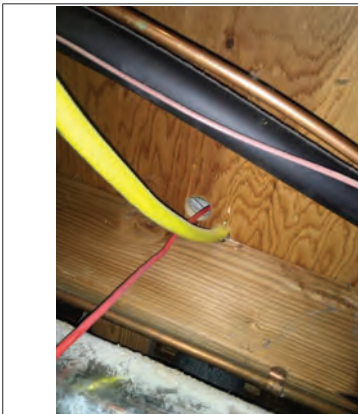
There is an extension cord used through the wall to operate a device (gas stove). This is a safety concern. Recommend a licensed electrician evaluate Or remove extension cord.

Extension cord used for stove

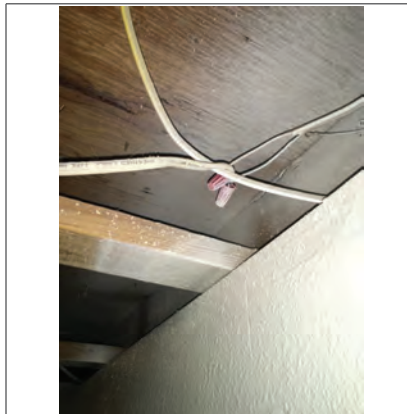
There were spliced wires found in the basement wiring. This is a potential fire hazard.

Spliced wires not in junction box

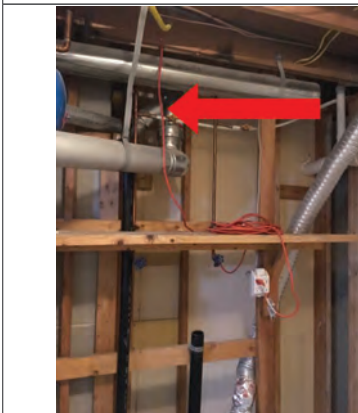
Extension cord to stove. No GFCI in basement

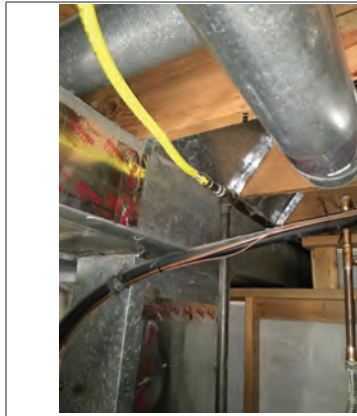
CSST (corrugated stainless steel tubing) may not be properly bonded. This is a safety concern as CSST can be damaged by lightning. Recommend a licensed plumber ensure CSST is properly bonded.

**Comments** CSST (corrugated stainless steel tubing) may not be properly bonded. This is a safety concern as CSST can be damaged by lightning. Recommend a licensed plumber ensure CSST is properly bonded.

CSST tubing may not be properly bonded

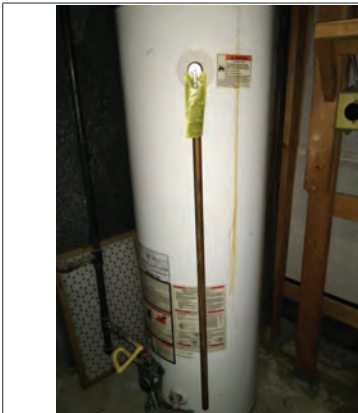
Water heater

The average life expectancy for a gas fired water heater is 8-12 years. Recommend budgeting for replacement.  
Manufactured 2009

**Comments** The average life expectancy for a gas fired water heater is 8-12 years. Recommend budgeting for replacement.  
 There are corroded pipes at the water heater. Recommend a licensed plumber repair.

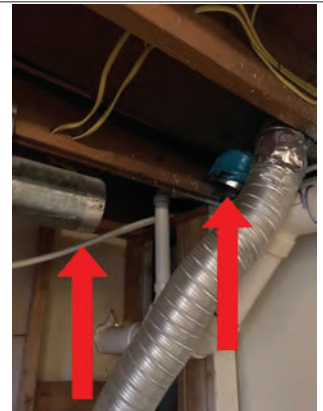
**Comments** Combustion air venting is disconnected at the top of the vent. See photo. Recommend reconnecting.

Combustion air venting not connected

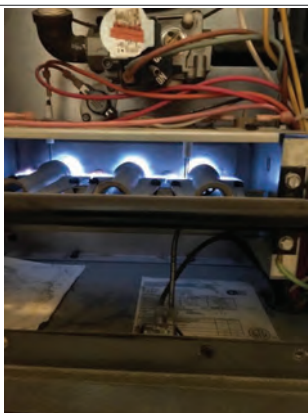
Furnace operation observed

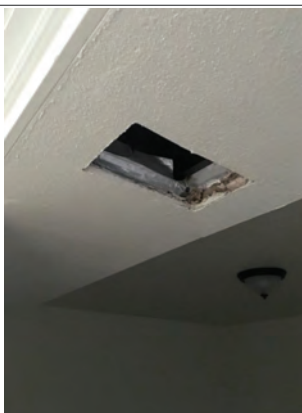
Missing register grill

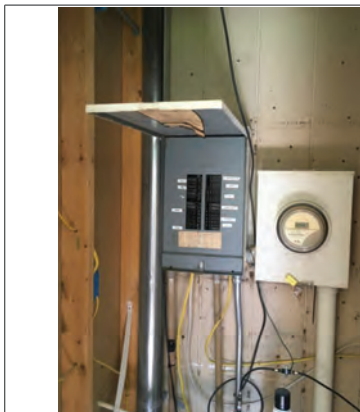
Main breaker panel

Panel circuit labeling may be incorrect or missing. Recommend labeling circuits as required.

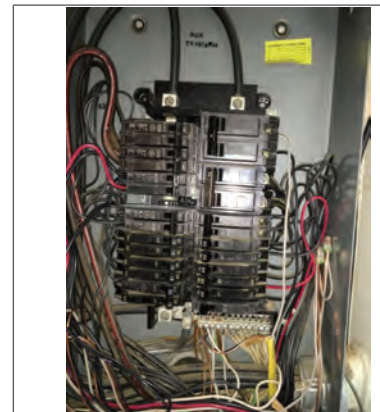
Panel cover removed for inspection

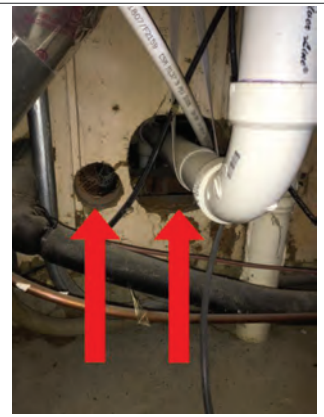
Holes in wall inside panel closet

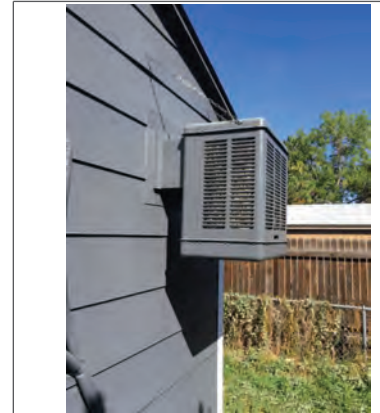
Abandoned swamp cooler on outbuilding

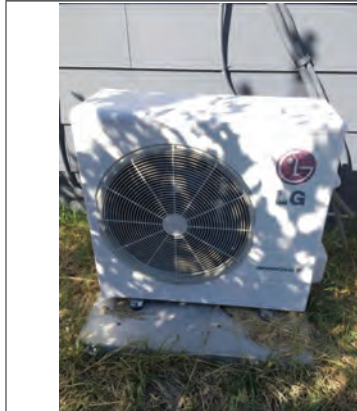
**Comments cont.** Outbuilding condensate line is not connected at wall and may discharge on top of sub panel enclosure in current condition. Recommend repair. See photo.  
Air conditioner on outbuilding could not be operated using the remote. It was undetermined if unit provided heat. Recommend replacing batteries in remote and testing unit for heat capability.

Air conditioning for outbuilding

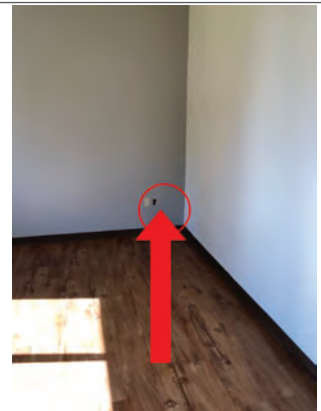
**Comments** There are holes in the wall or ceiling. Recommend repair as needed.

Hole in wall

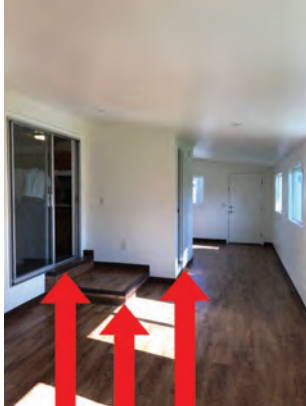
Upstairs family room  
Varied step heights

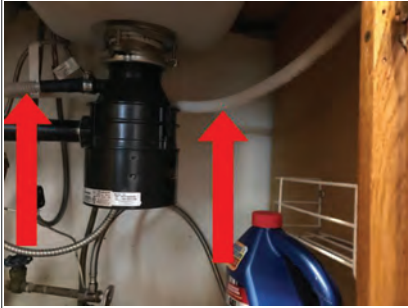
Dishwasher drain line is not high looped beneath countertop. This could allow cross contamination between the sink and the dishwasher. Recommend installing a drain high loop.

Dishwasher drain is not high looped

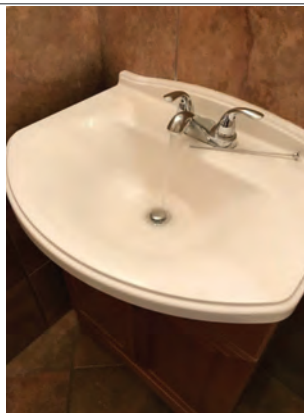
Sink stopper needs repaired

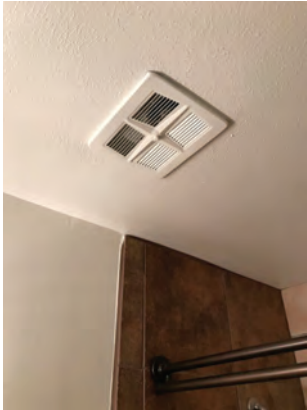
Noisy and dirty exhaust fan

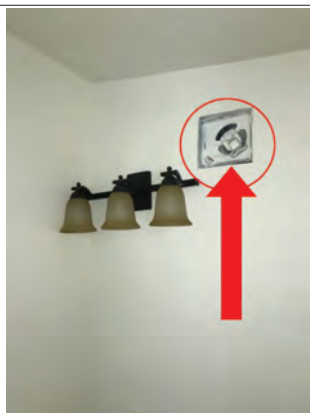
Exhaust fan has missing covering

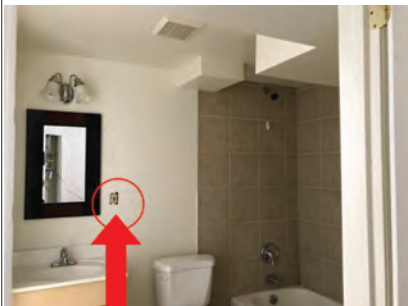
Basement bathroom  
Receptacle cover plate is missing

**There is at least one receptacle cover missing in the bathroom. This is a safety concern. Recommend installing a cover as needed.**  
The exhaust fan was not operating in the bathroom. Recommend repair or replacement as needed.  
The exhaust fan grill cover is dirty. Recommend cleaning to allow exhaust to work more efficiently.  
There was no sink stopper installed in the sink. Recommend repair as needed.  
The tub and/or vanity finish is chipped. Recommend repair or replace as needed.  
Light does not always illuminate. Sometimes the switch illuminated immediately or delayed and other times it did not. Have licensed electrician evaluate.

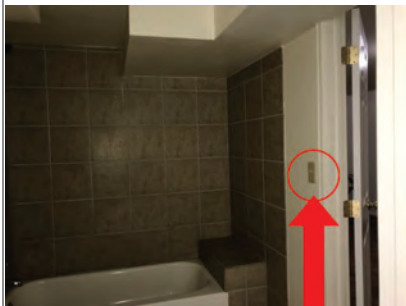
Basement bathroom  
Light switch shows in the on position but no light illuminated the bathroom. It intermittently worked.

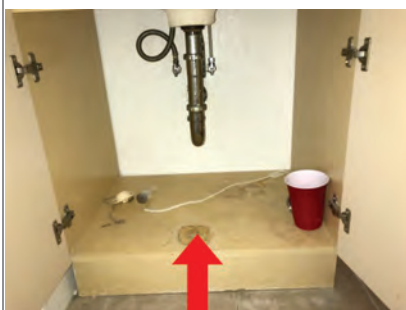
Damage to bottom of cabinet

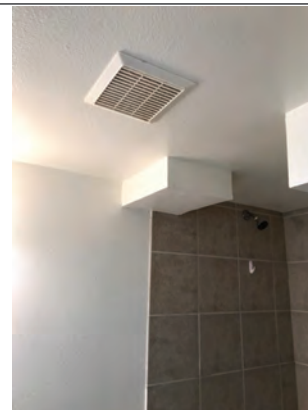
Inoperable exhaust fan

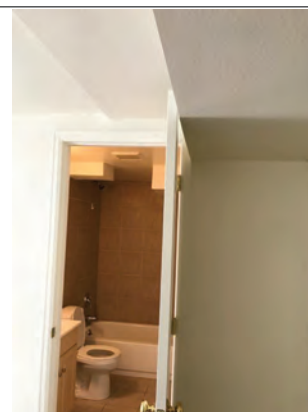
No door stop

**Comments** Recommend cleaning/replacing the caulking/grouting in shower/tub area to help prevent damage from water penetration.  
The bathroom door does not latch shut completely. Repair or adjust as needed.  
Recommend installing a door stop to help prevent damage to the wall from the door handle.  
The drain in the tub or sink is marginal. This could be caused by a dirty stopper or trap. Recommend a licensed plumber evaluate and repair as needed.

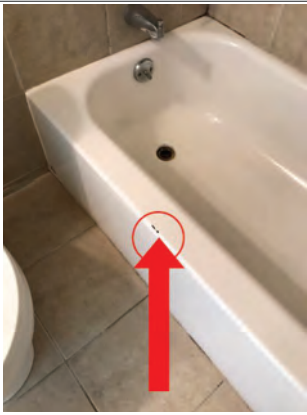
Chip on tub

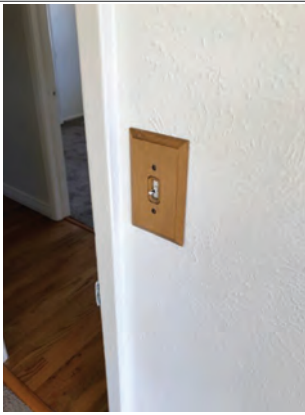
Missing light switch

<b>Comments</b>	<p>There are loose receptacles in this room. Recommend a licensed electrician repair.</p> <p>There was no smoke detector installed in the room. This is a safety concern. Recommend installing a smoke detector per manufacturers instructions inside the bedroom for additional safety.</p> <p>There is evidence of leaking insulated glass on the window. Recommend repair/replacement of window.</p> <p>Screen is missing from window. Inquire of homeowner.</p> <p>Recommend replacing incandescent light with a enclosed LED light in the closet.</p> <p>There is at least one damaged receptacle and a switch knob is missing. Recommend licensed electrician replace.</p>

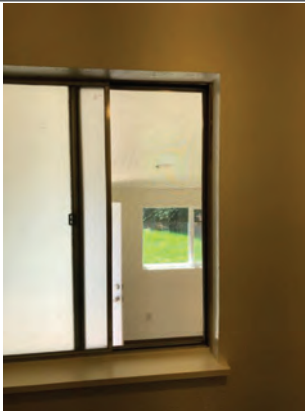
Closet window opens to upstairs family room

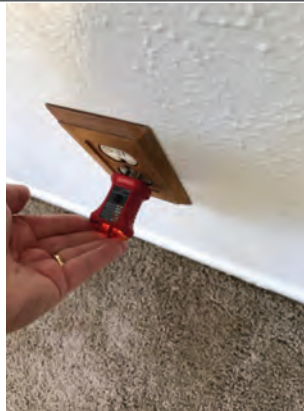
Loose receptacle

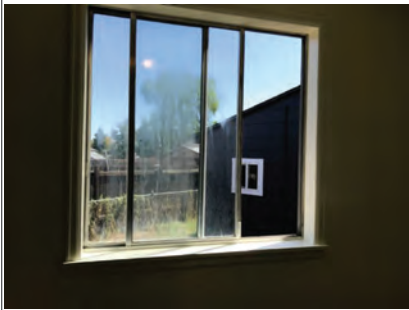
Window has evidence of leaking gas

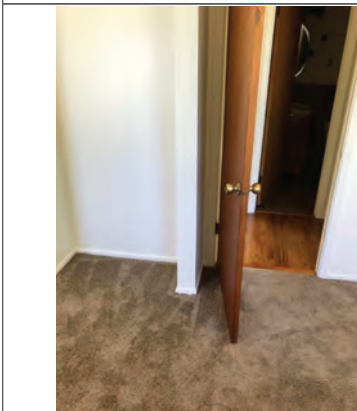
No door stop

Recommend installing a door stop. Door stops help prevent damage to the wall from the door knob.

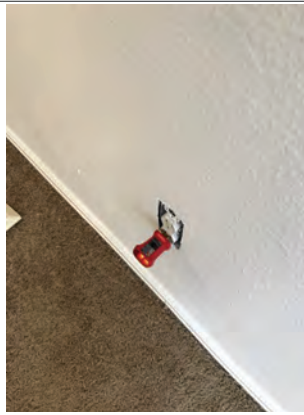
Loose receptacle and missing cover plate

<b>Comments</b>	<p>At least one cover plate is missing at a receptacle in this room. This is a safety concern. Recommend installing cover plates.</p> <p>There are loose receptacles in this room. Recommend a licensed electrician repair.</p> <p>The small window is very difficult to open and/or close. Recommend a licensed contractor evaluate and repair as needed.</p> <p>Heater vent cover not in place.</p> <p>Recommend installing a door stops. Door stops help prevent damage to the wall from the door knob.</p> <p>Recommend installing a strike plate to help prevent damage to the door frame.</p> <p>Recommend replacing incandescent light with a enclosed LED light in closet.</p> <p>There was no smoke detector installed in the room. This is a safety concern. Recommend installing a smoke detector per manufacturers instructions inside the bedroom for additional safety.</p> <p>There is no CO detector located near bedroom entrance. This is a safety hazard. Install CO detector per manufacturers recommendations.</p>

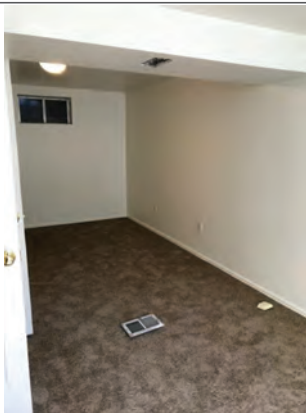
Heat vent cover fell while in room

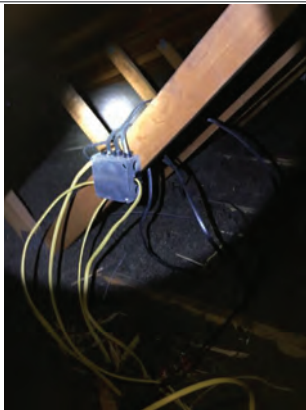
Handyman wiring

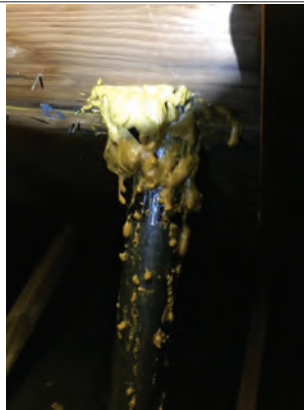
Unprofessional exhaust fan insulation.

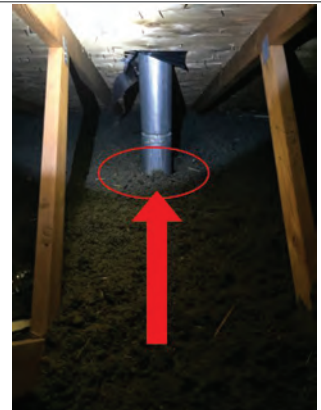
**Comments** **The furnace/water heater flue pipe in the attic is in contact with insulation. This is a potential fire hazard. Recommend removing insulation against pipe and maintaining space requirements per manufacturers instructions from combustible materials.**  
**The attic did not appear to have adequate insulation. Recommend consideration be given to adding insulation in the near future.**  
**Consider additional ventilation in attic such. Additional ventilation can assist with heating and cooling costs and lengthen the life of normal shingle wear.**

Furnace and water heater exhaust vent in contact with insulation. Create void space with shroud.

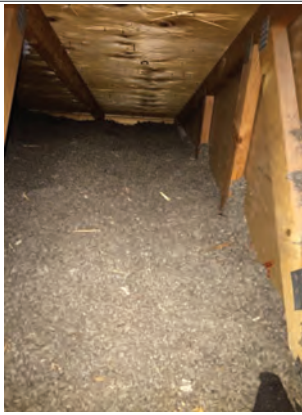
Insulation

**Insulation** ☐ Fiberglass ☐ Batts ☒ Loose ☐ Cellulose ☐ Foam ☐ Other ☐ Vermiculite ☒ Rock wool  
Depth (inches): see photo ☐ Damaged ☐ Displaced ☐ Missing ☐ Compressed  
☒ Recommend additional insulation
